UNITED STATES COAST GUARD

**INVESTIGATION INTO THE CIRCUMSTANCES
SURROUNDING THE SINKING OF THE**

TALL SHIP BOUNTY

**123 MILES OFF THE COAST OF CAPE
HATTERAS, NORTH CAROLINA ON OCTOBER
29, 2012 WITH LOSS OF ONE LIFE AND
ANOTHER MISSING AND PRESUMED DEAD**

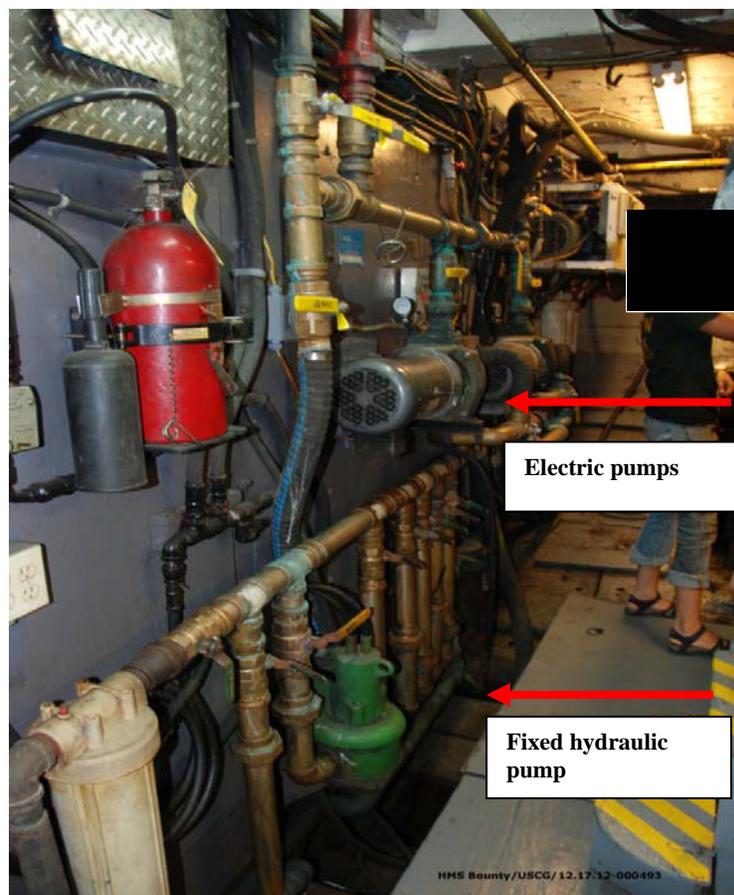
tank. This pump was considered by the crew to be the “portable” hydraulic pump. The four inch suction was unobstructed, and the pump was equipped with a three inch hose that discharged on the starboard side just aft of the thru-hull for the two inch manifold discharge. Witness testimony reported that these pumps were rarely used, and only expected to be used for emergency. Only Capt. [REDACTED] was familiar with the operation of these pumps.

Figure 4 The BOUNTY's bilge system with two electric pumps mounted above the bilge manifold and the green fixed hydraulic is below.

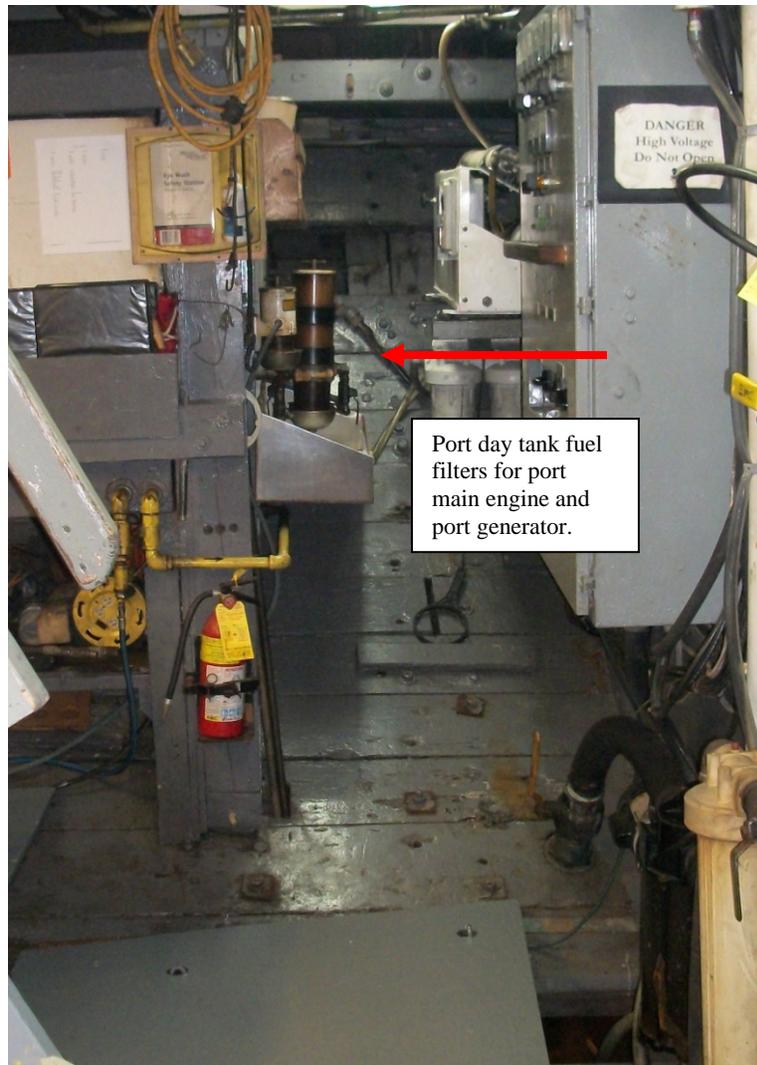
Figure 5 BOUNTY's port day tank and fuel filters.

29. According to crew testimony, on the BOUNTY, it was the job of the engineer to press up the day tanks in the engine room from the main fuel tanks via an electrical transfer pump, although this is not detailed in any written policy. Engineer [REDACTED] reported that he did so each morning. It was the job of the deckhands to check and record the fuel level in the day tanks every half hour while underway. Day tank fuel readings were taken via a sight glass on each tank. While underway, the BOUNTY used approximately 10 – 12 gallons of fuel per hour from each day tank under normal operating conditions.

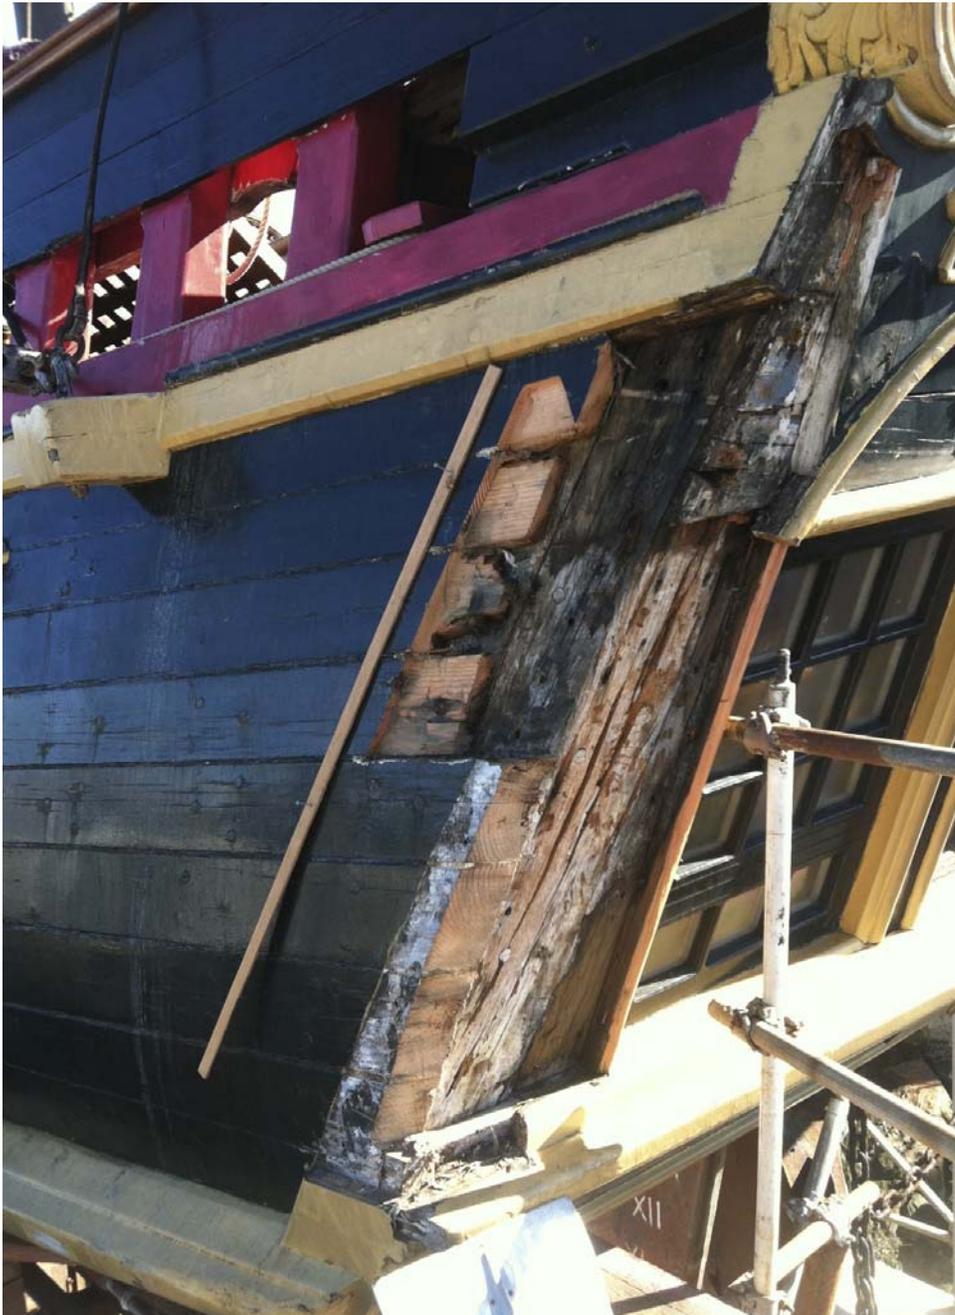
Figure 6 BOUNTY's Port quarter

and visible rot was removed from the exposed frames. The oil based primer was once again applied, and the area was closed up.

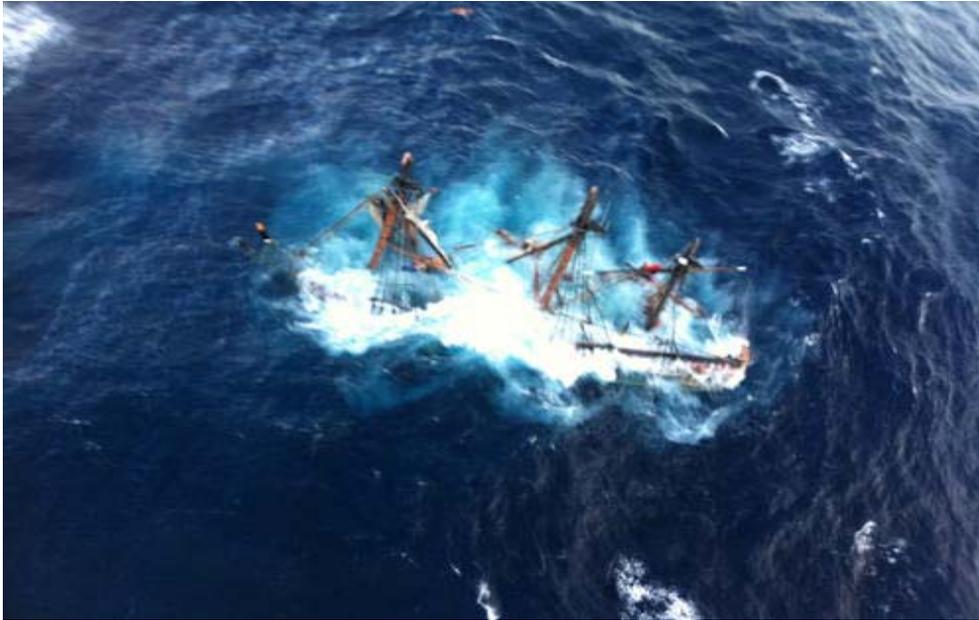
Figure 13 photo of BOUNTY taken by CG 6043 air crew member

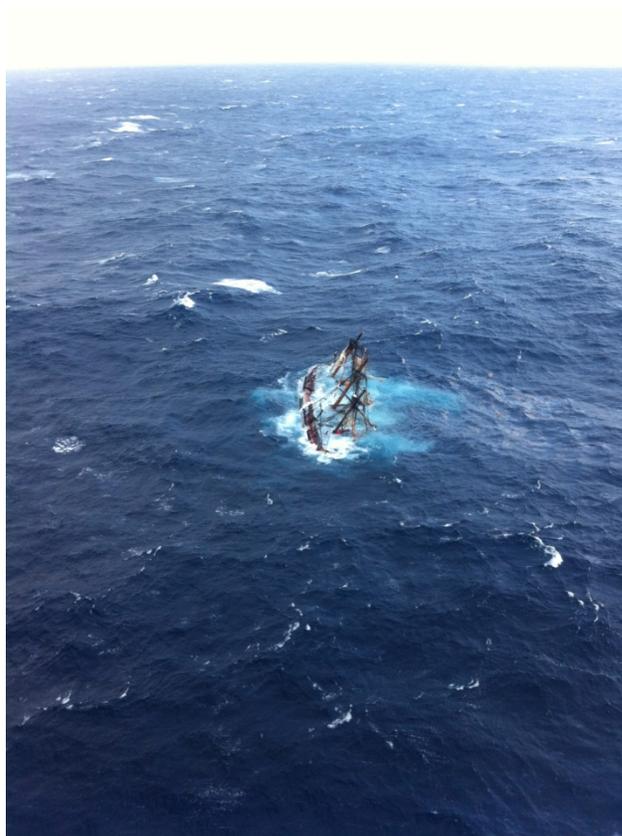
Figure 14 photo of BOUNTY taken by CG 6043 air crew member

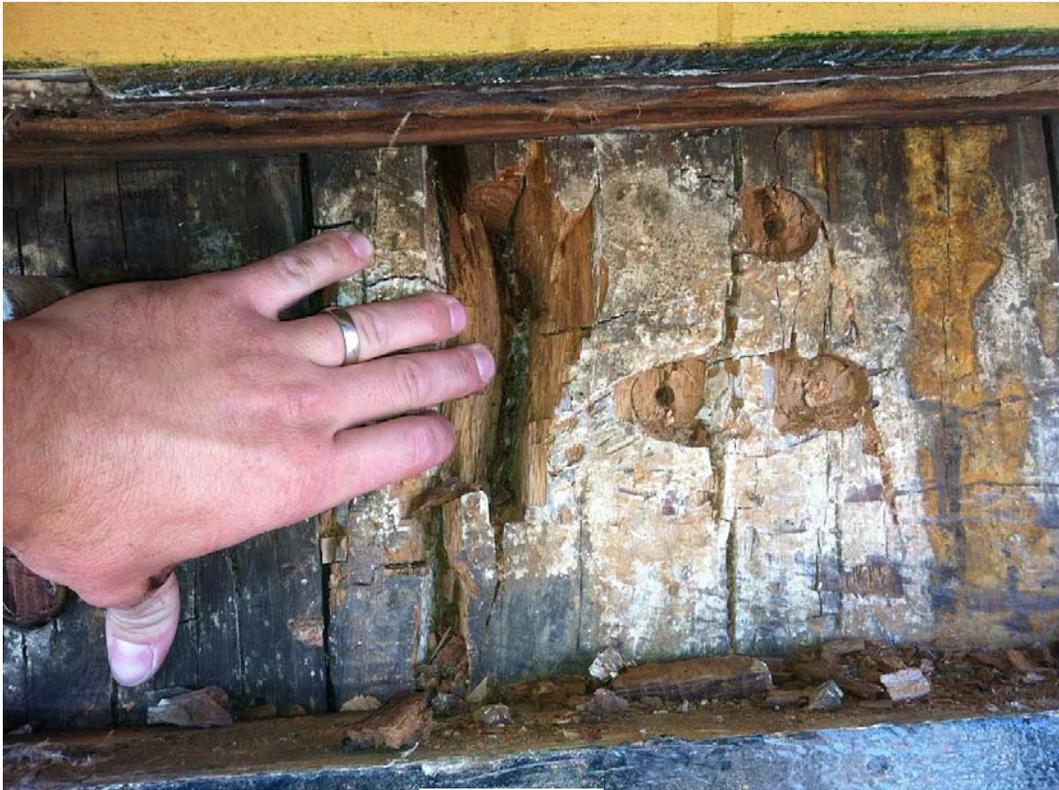
Testimony from Mr. [REDACTED] differed from Mr. [REDACTED], in that Mr. [REDACTED] believed the decay problem was more serious. However, both provided testimony that they believed the vessel was capable of making it to the next haul out, tentatively scheduled for the following year, when the vessel left Boothbay Harbor Shipyard.

Figure 17 Photo of frame decay taken by [REDACTED].

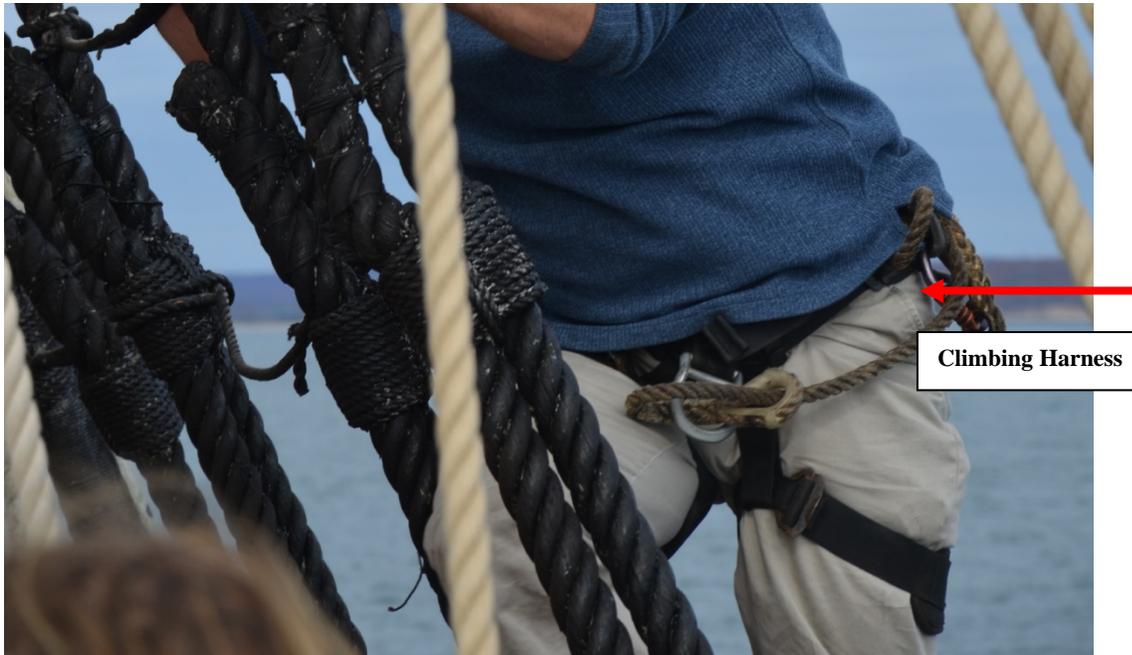
Figure 19 Climbing harness

34. The merits and drawbacks of wearing the climbing harnesses (see Figure 19) or riggers belt with the immersion suit was also discussed. Wearing of the belts almost caused Deckhand [REDACTED] and AB [REDACTED] to be dragged underwater, but some crew said it was easier to pull crew members into the raft because of it. The Stearns model 1590 immersion suits were an older model of immersion suit. Many of the newer model immersion suits come with clips that are built into the suit, and are flush to the chest so they will not get caught up. No one on the BOUNTY crew stated that they ever trained to use their climbing harness over their immersion suit. No one on the crew who had been on other vessels or attended BST ever had this practice taught or recommended. No BST training facility or manufacturer of immersion suits recommends placing any item, including other PFDs, on top of an immersion suit.
