UNITED STATES COAST GUARD

**INVESTIGATION INTO THE CIRCUMSTANCES
SURROUNDING THE SINKING OF THE**

TALL SHIP BOUNTY

**123 MILES OFF THE COAST OF CAPE
HATTERAS, NORTH CAROLINA ON OCTOBER
29, 2012 WITH LOSS OF ONE LIFE AND
ANOTHER MISSING AND PRESUMED DEAD**

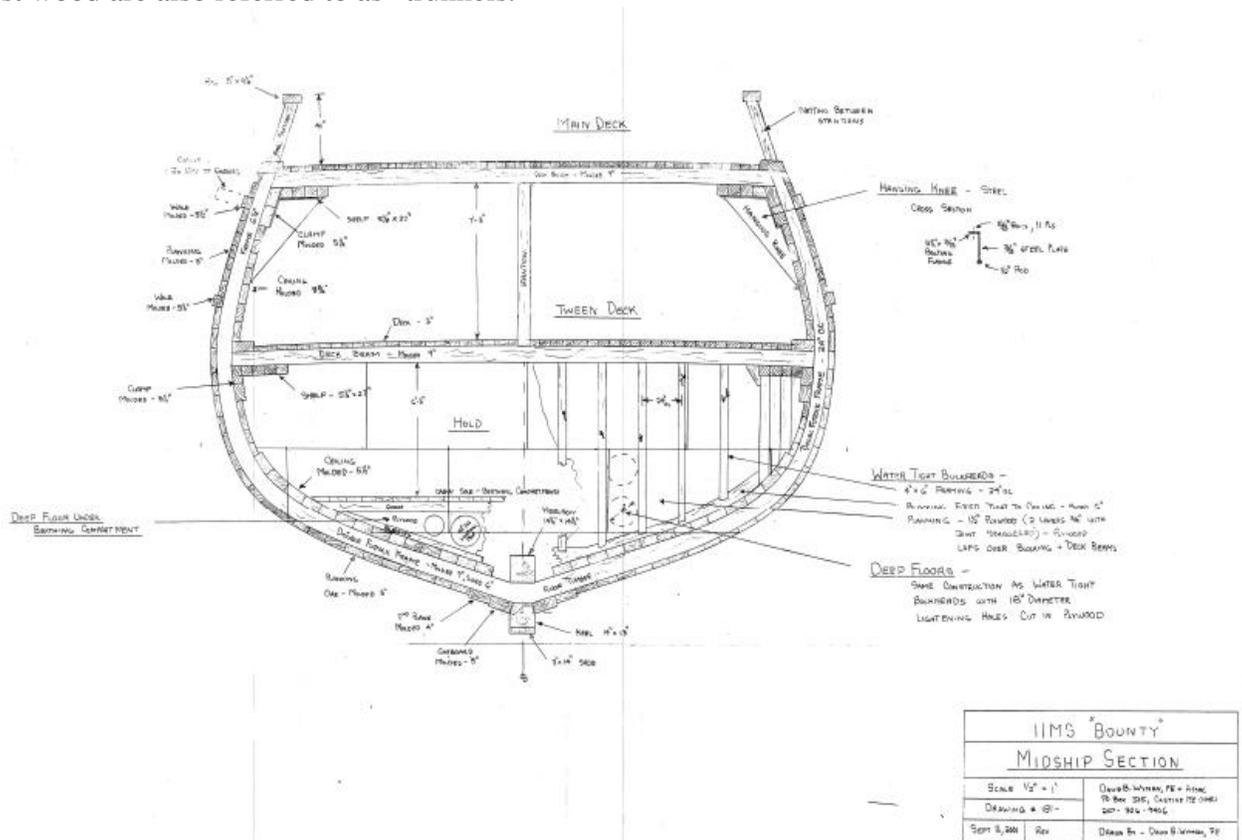
Figure 2 BOUNTY’s Midship section

5. The vessel was of traditional “Carvel” plank on frame construction (see Figure 2), characterized by flush plank edges run in fore and aft rows referred to as strakes. The first plank outboard of the keel is referred to as the garboard strake, and the top, or upper most plank, in the hull is referred to as the sheer strake. The planks were primarily 3 inches thick by eight inches wide, with the garboard plank and wale boards being 5 inches thick. The planks were affixed to the frames using fasteners made of galvanized spikes, or black locust wood. The fasteners made of locust wood are also referred to as “trunnels.”

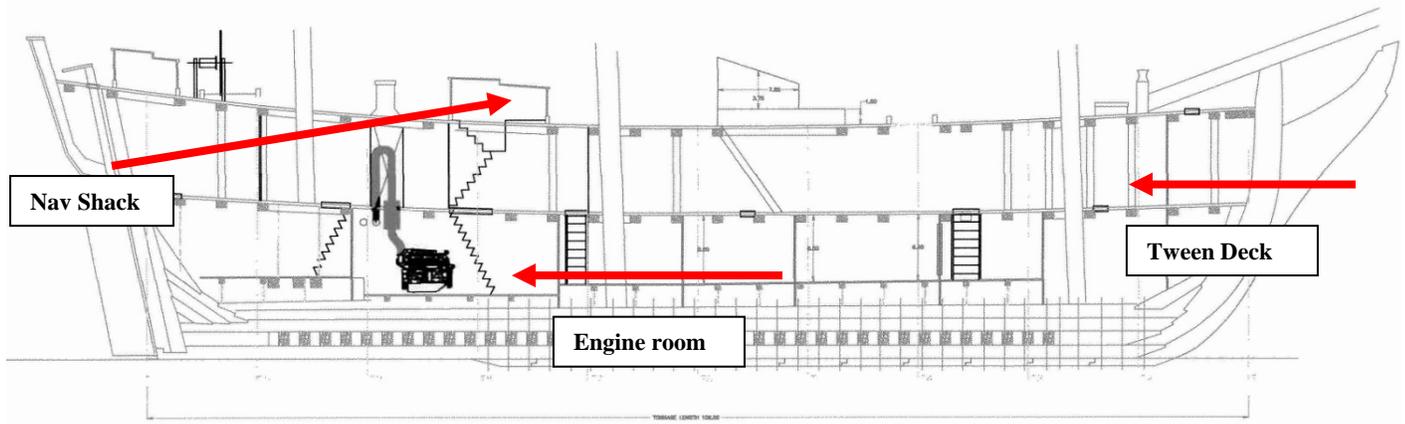
Figure 3 BOUNTY inboard profile

8. BOUNTY had three decks (see Figure 3). The main or weather deck was the upper most deck and open to the weather. BOUNTY’s helm was located on the weather deck at the stern. Beneath this was the tween deck, where the galley, crew mess, and public area were located. The tween deck was continuous from stem to stern, with no separating bulkheads between compartments. Most navigation and communications equipment was located on a landing deck between the weather deck and tween deck called the “Nav Shack.” Access from the weather deck was located forward of the helm, mizzen mast and capstan. The lowest most deck, above the deep floors, was referred to as the lower hold. The lower hold spaces included the lazarette, engine room, fuel/water tank compartment and crew berthing spaces. The lower hold was divided by transverse bulkheads at frames #5, 11, 17, 23, 30, 35, and 45. Deep floors at the transverse bulkheads had 18 inch lightening holes in them for the passage of pipes and wire conduits rendering them non-watertight.

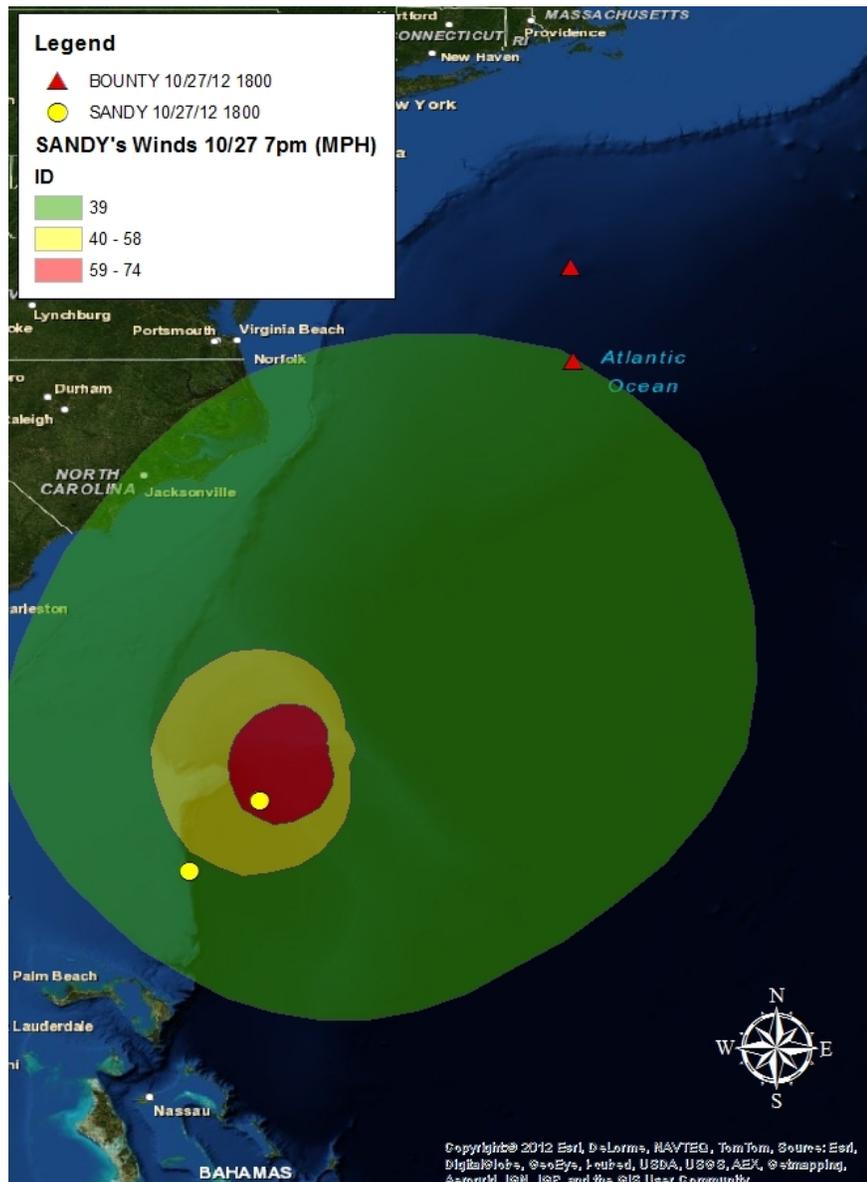
Figure 7 BOUNTY 488 NM from center of Hurricane Sandy

123. At 1800 BOUNTY was 488 NM from the center of Hurricane Sandy (see Figure 7).

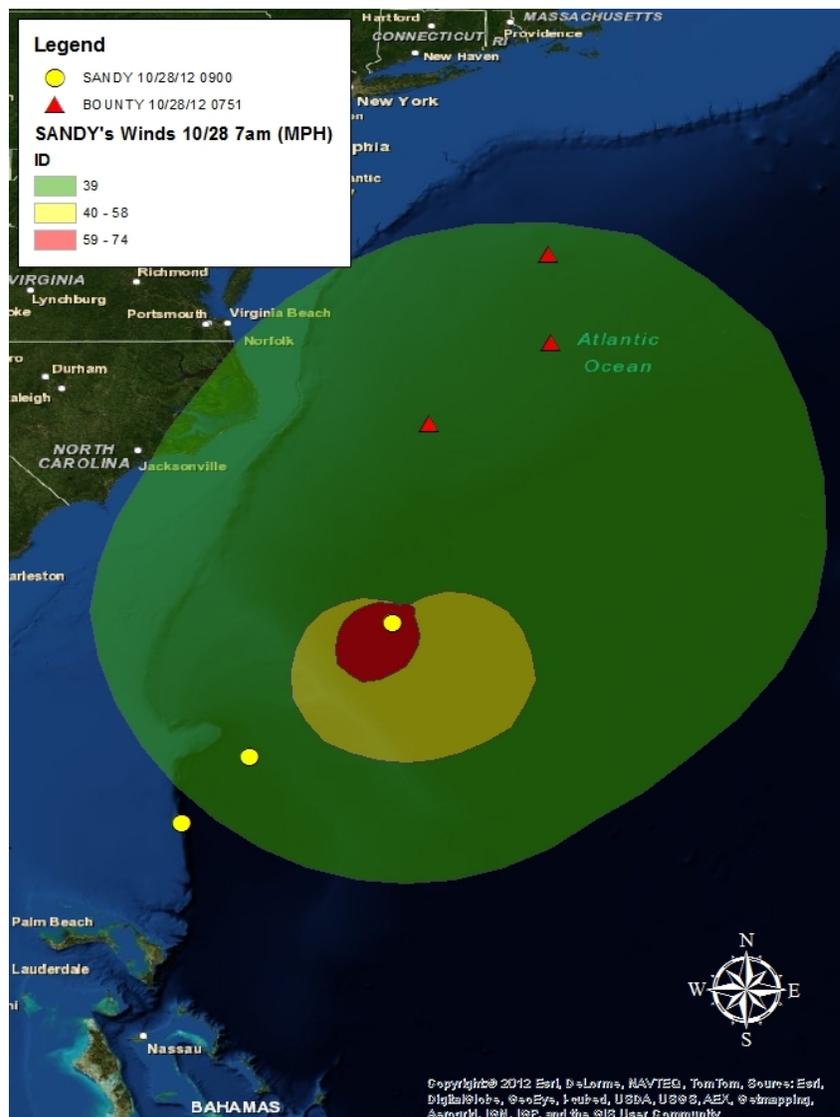
Figure 8 BOUNTY approximately 226 NM from center of Hurricane Sandy

129. At 0900, BOUNTY was approximately 226 NM from the center of Hurricane Sandy (see Figure 8).

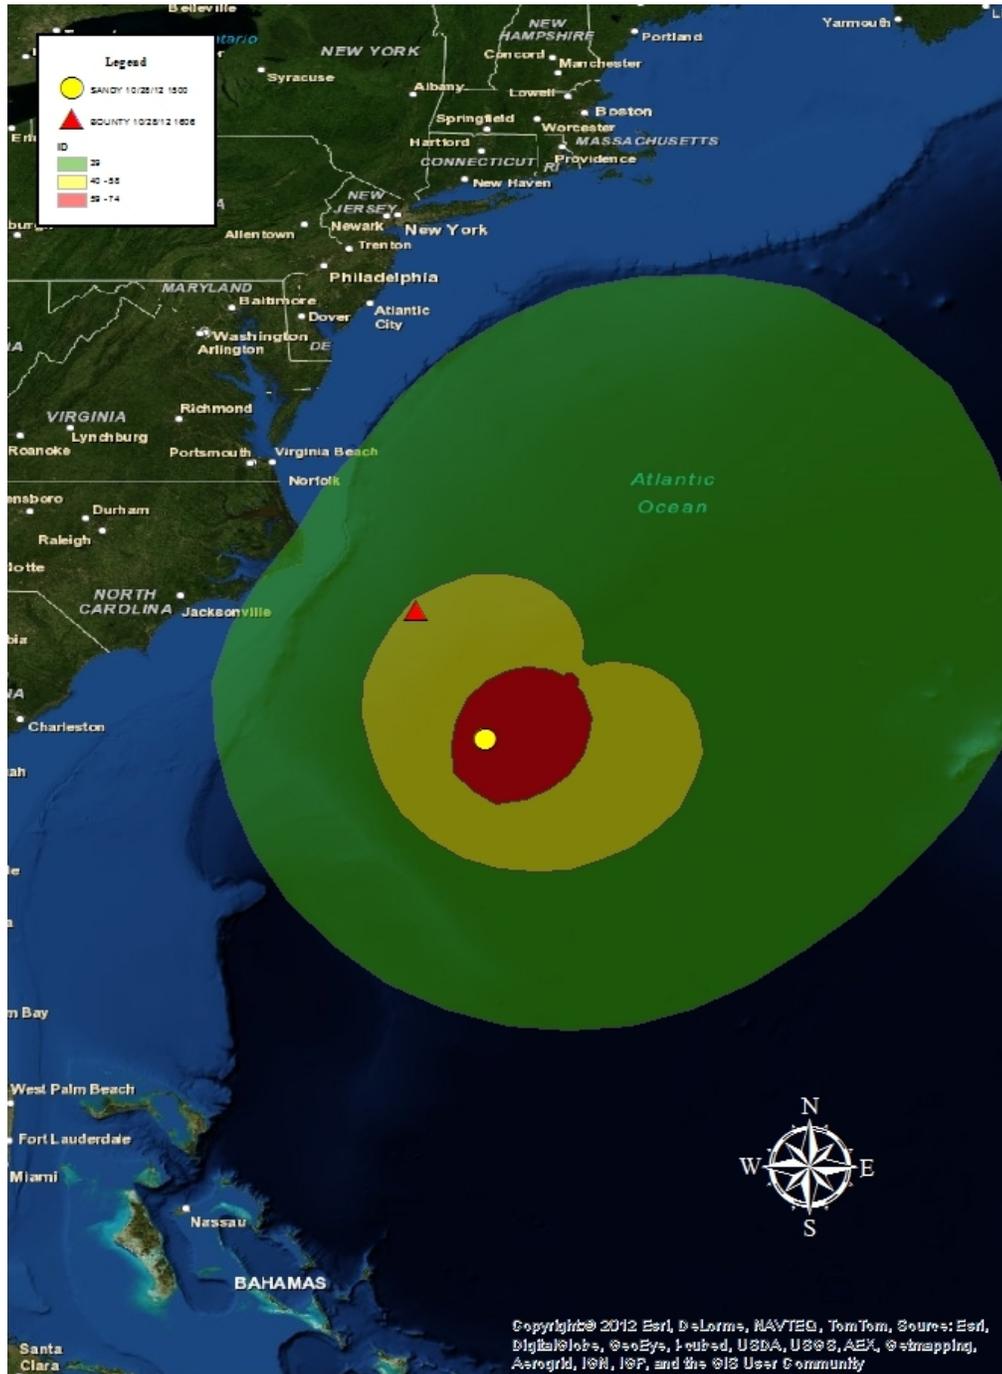
Figure 9 BOUNTY is approximately 132.5 NM from the center of Hurricane Sandy.

152. At 1600, BOUNTY was approximately 132.5 NM from Hurricane Sandy. This was the closest point of approach. (see Figure 9)

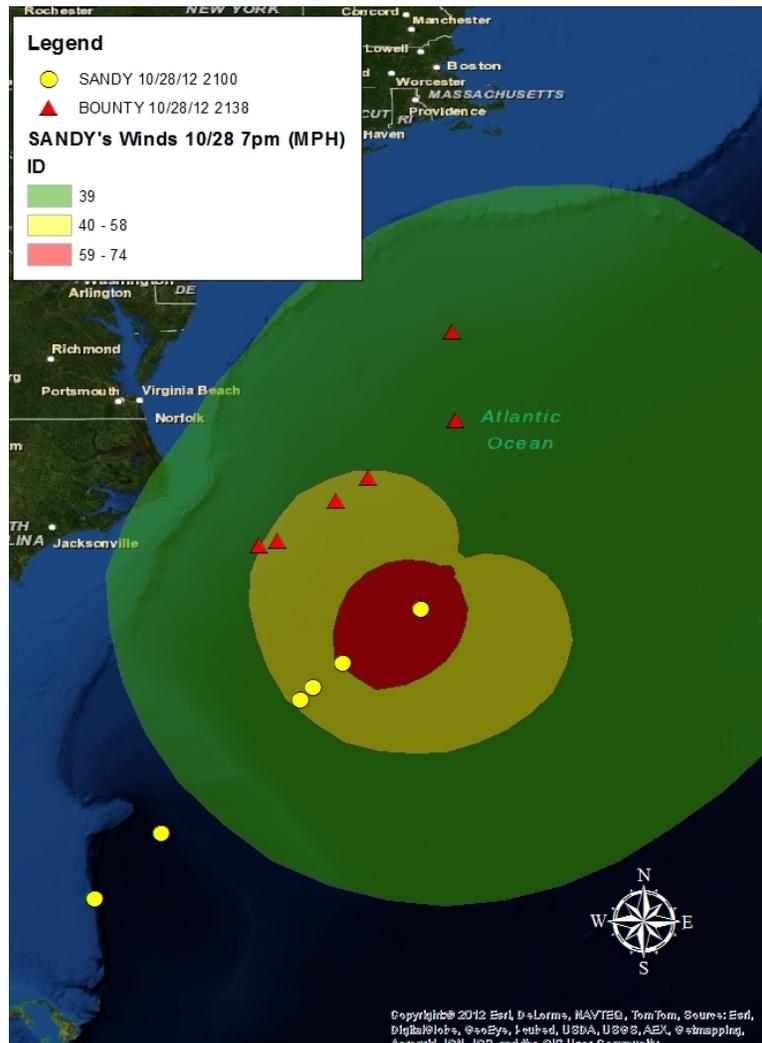
Figure 10 BOUNTY is 147.5 NM from the center of Hurricane Sandy.

173. At 2100, BOUNTY was approximately 147.5 NM away from the center of Hurricane Sandy. (see Figure 10)

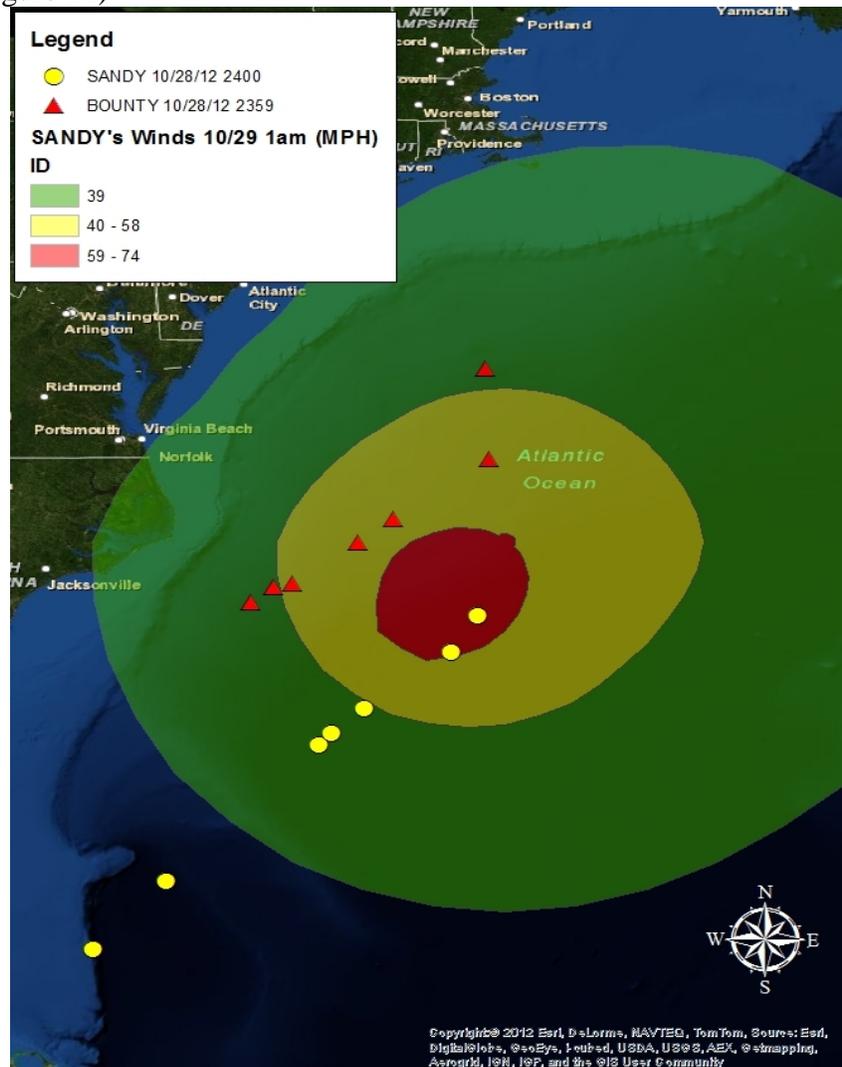
Figure 11 Hurricane Sandy is approximately 170.6 NM from the Center of Hurricane Sandy.

190. At midnight, BOUNTY was approximately 170.6 NM away from the center of Hurricane Sandy. (See Figure 11)

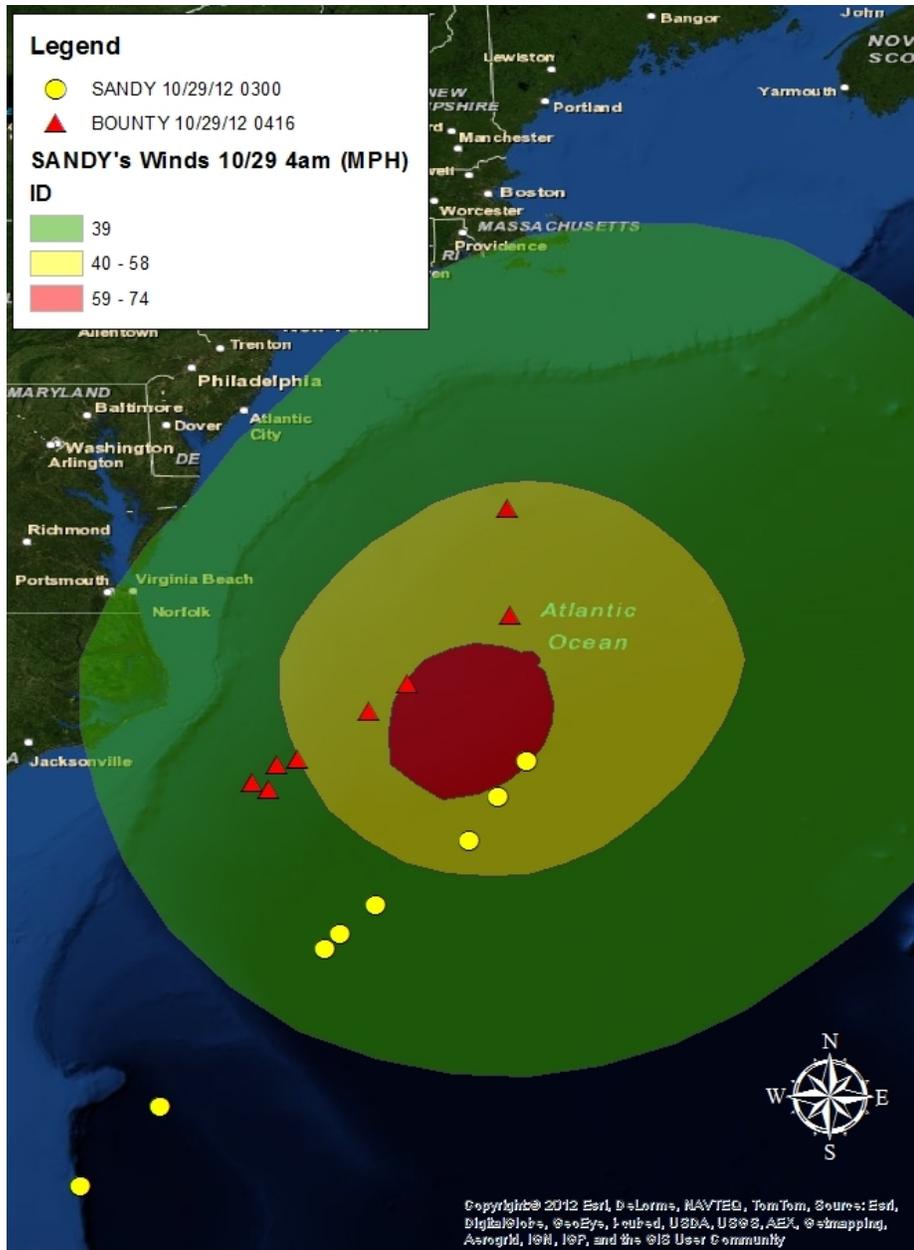
Figure 12 BOUNTY is approximately 181.3 NM away from Hurricane Sandy

205. At 0400, BOUNTY was approximately 181.3 NM away from the center of Hurricane Sandy (see Figure 12)

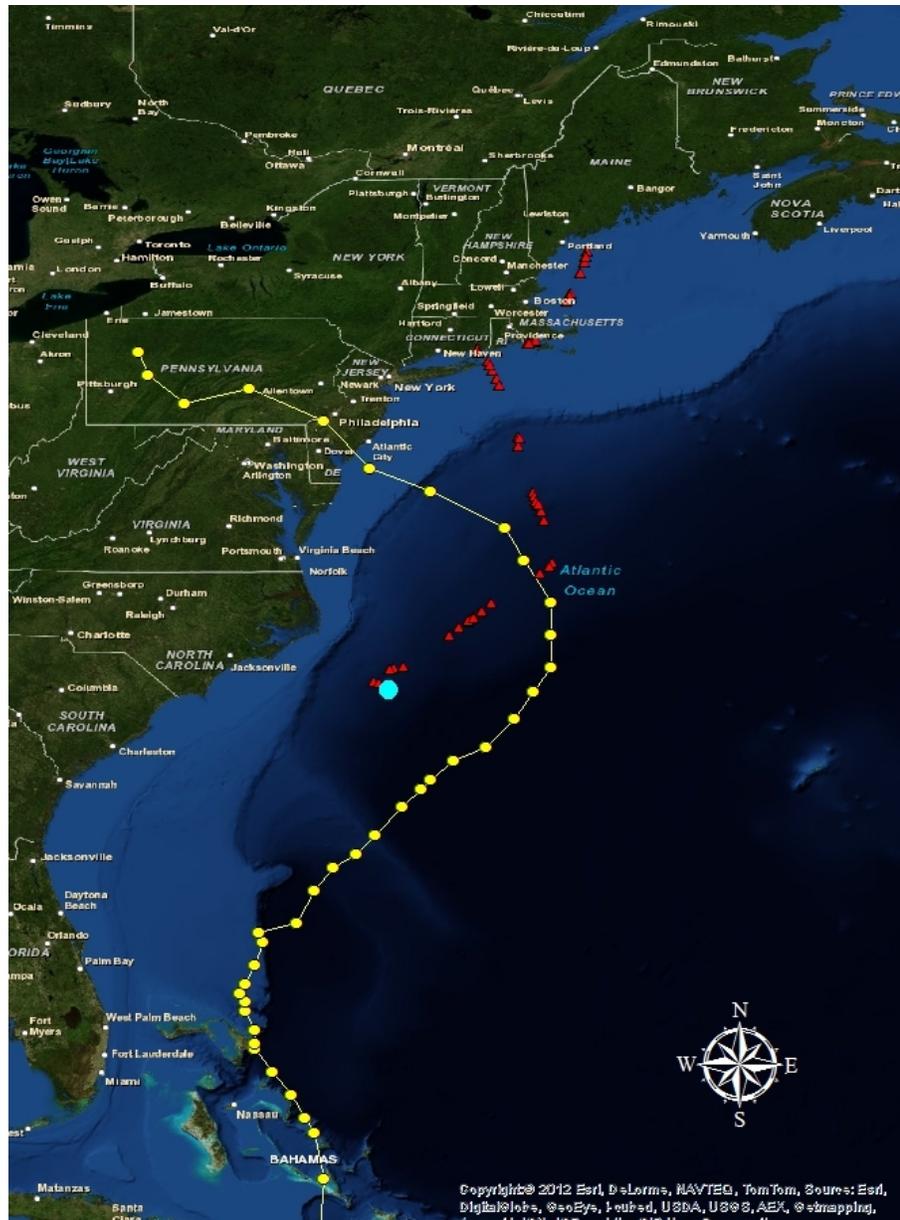
Figure 16 complete track for BOUNTY and Hurricane Sandy.

8. An analysis of the BOUNTY’s voyage track was prepared by the Coast Guard Investigations National Center of Expertise. The analysis is based on maritime practice and the documented actions taken by Capt. [REDACTED]. This analysis utilized the vessel’s track data and environmental conditions experienced during the voyage. The analysis is valid for this voyage only and uses scientific and meteorological principles for the sea area of the BOUNTY’s voyage track. (See Figure 16)

Upon changing course southwest, BOUNTY faced an opposing Gulf Stream current averaging four miles per hour, which caused a reduction in the vessel's speed over the ground. Hurricane Sandy continued northeast at 14 miles per hour. This was only exacerbated when BOUNTY lost her port main engine due to lack of fuel. As the BOUNTY proceeded southwestward with winds from the east northeast and northeast over the stern and port quarter, high steep waves and confused seas with shorter wave periods would be experienced due to the opposing Gulf Stream current. Breaking waves over the stern increased as the wind speed increased while BOUNTY

navigated closer to the hurricane center. The opposing currents and water temperatures creates a well documented phenomenon termed the North Wall Effect, and this is ultimately the consequences experienced by the BOUNTY and her crew.

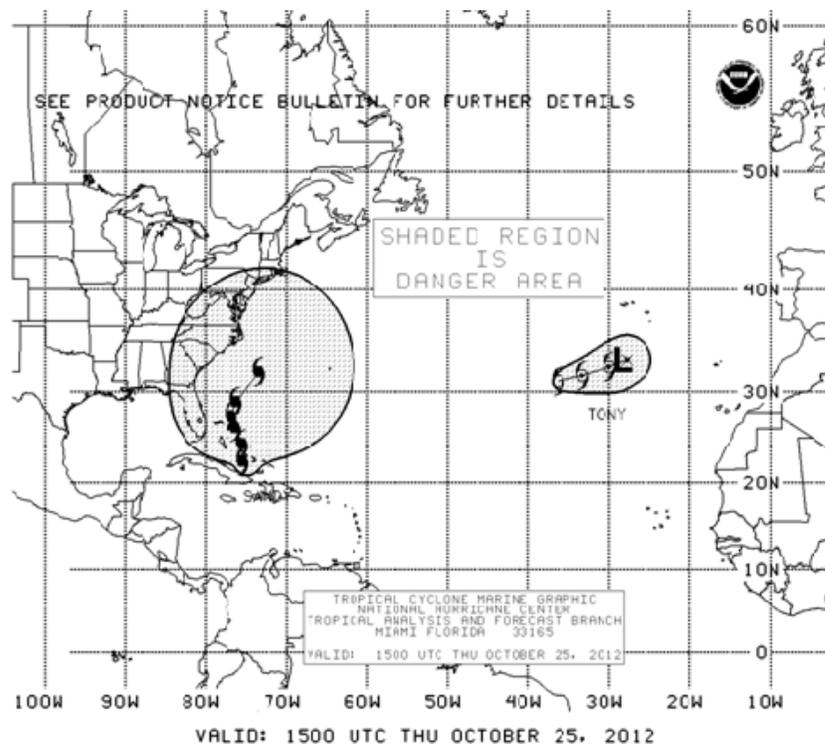
Figure 16. Hurricane Sandy graphic for October 25th 1300 EST.

An important rule for mariners to apply in order to avoid hurricanes is the Mariner's 1-2-3 rule, also referred to as the Danger Rule. It refers to the rounded long-term National Hurricane Center (NHC) forecast errors of 100-200-300 nautical miles at 24-48-72 hours, respectively. According to the Mariner's Guide for Hurricane Awareness in the North Atlantic Basin⁴ "The 3-day forecast track of each active tropical cyclone is depicted along with a shaded "danger" region, or area of avoidance (see Figure 16). The danger area is determined by adding 100, 200, and 300 nautical miles to the tropical storm force radii (34 knots) at the 24-, 48-, and 72-hour forecast positions, respectively (hence the Mariner's 1-2-3 rule). Users operating in the vicinity of these systems are advised to continually monitor the latest forecasts and advisories issued by the National Hurricane Center." During the hearing, C/M ██████████, 2/M ██████████ and 3/M ██████████ were questioned on whether or not Capt. ██████████ had used the Mariner's 1-2-3 Rule or 34 knot Rule during voyage planning. Each stated they had either not heard of it or did not know if Capt. ██████████ applied it in an attempt to avoid Hurricane Sandy.

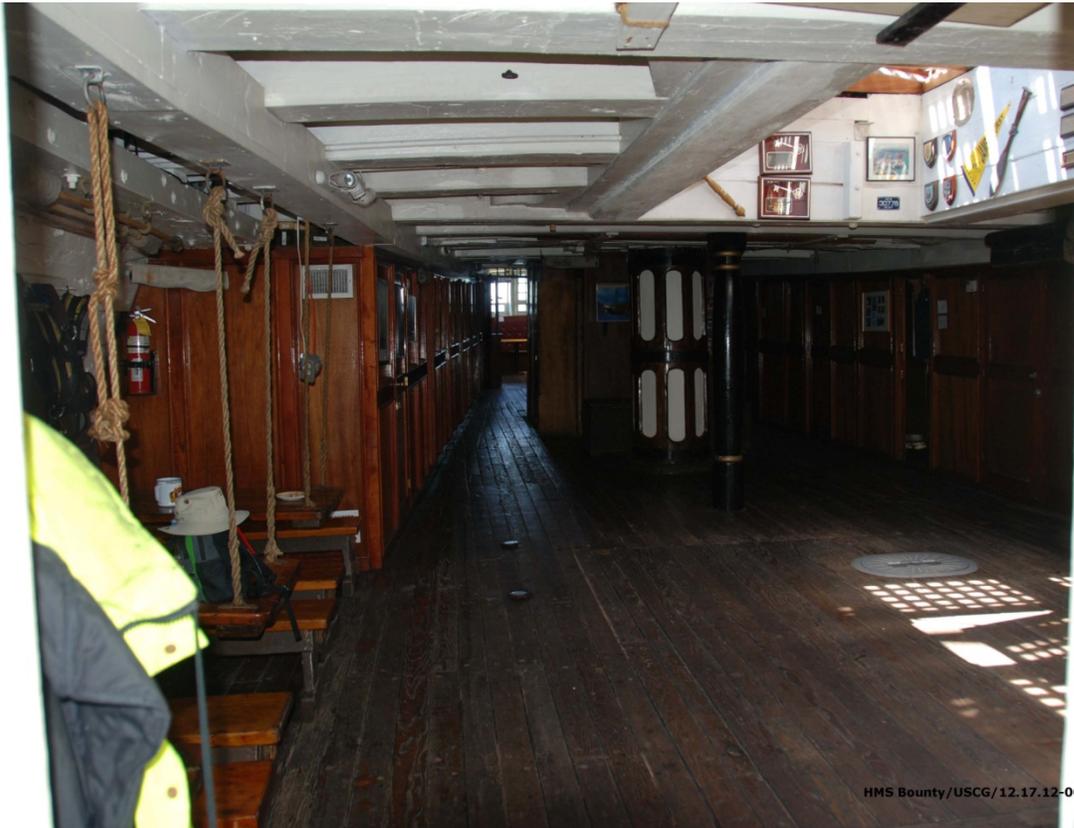
Figure 18 Tween Deck

- The tween deck (Figure 18), which had been designated as the freeboard deck by the owner, was observed as having a large area of free surface and only one 6 inch scupper on the port and starboard side.
